The Butler Trail at Lady Bird Lake

Urban Forestry and Natural Area Management Guidelines

The Trail
Foundation

Produced by Siglo Group, 2015

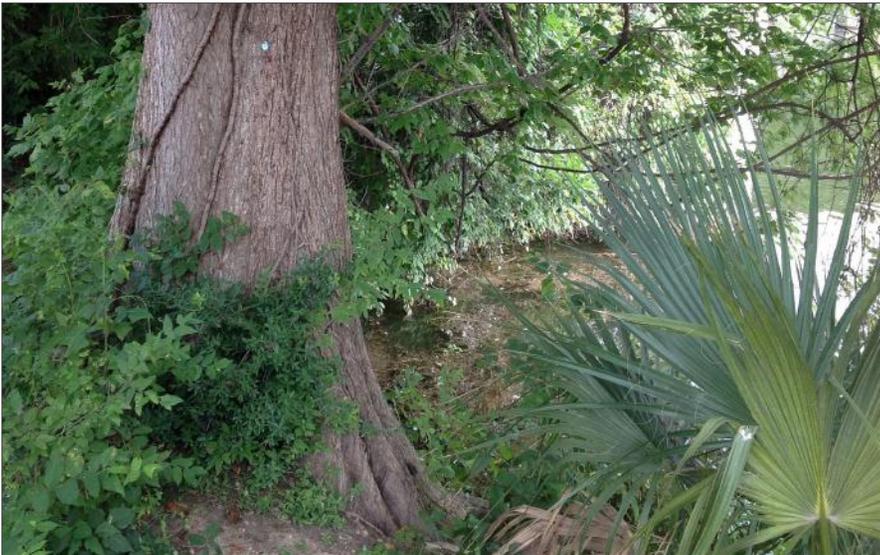
Figure 2.23: The Shoreline Woodland is characterized by large bald cypress and is generally only one tree wide, as seen here just east of 1st Street on the south shore

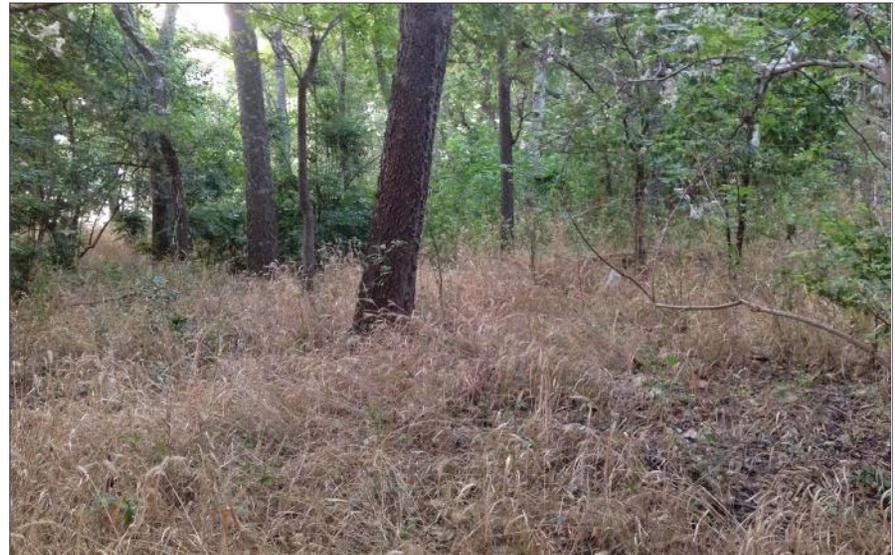
Figure 2.24: Sugar hackberry is the most abundant tree in the Floodplain Terrace Woodland, and the community often lacks a dense shrub layer, as seen here just west of MoPac on the south shore.

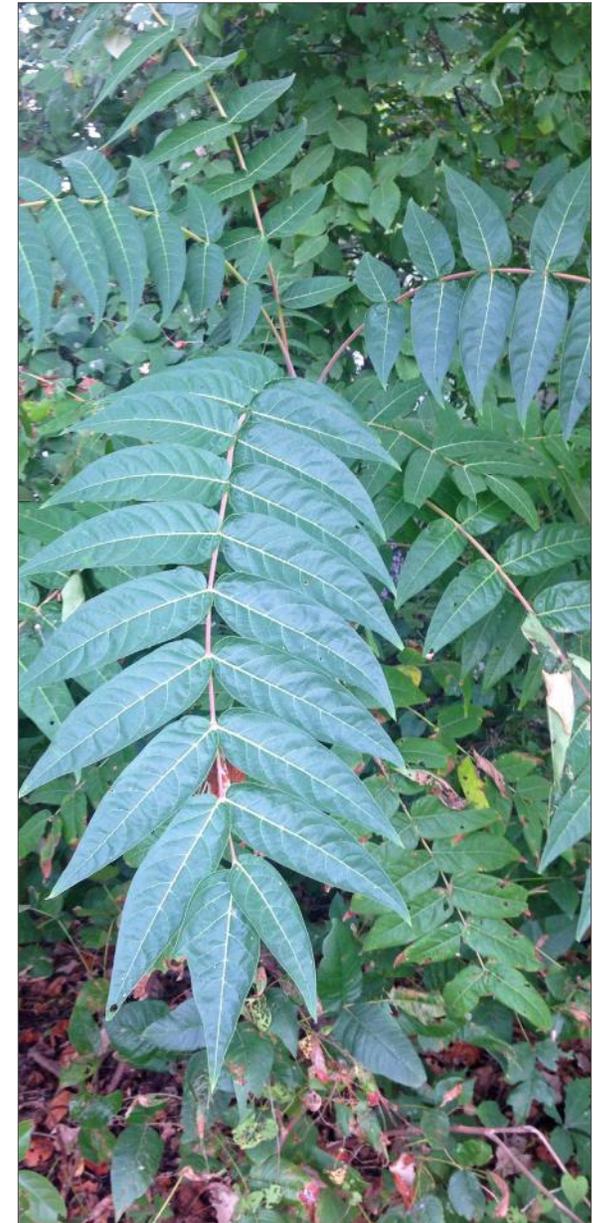
Figure 2.32: Tree of heaven is found in only a few locations in the study area but is capable of forming dense stands.

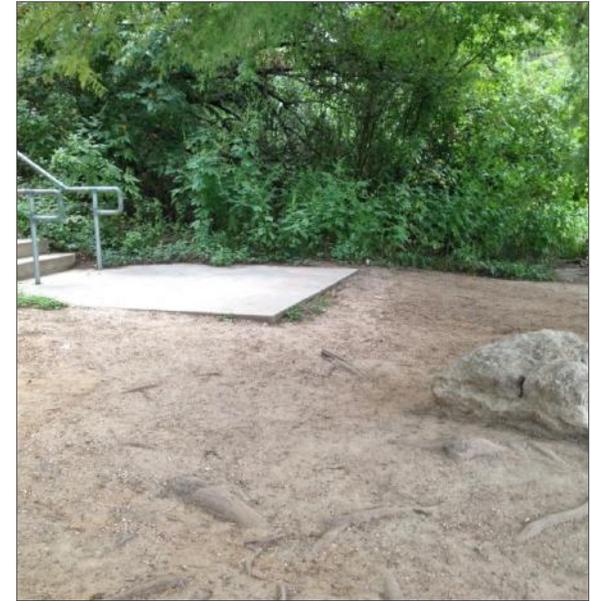
Figure 2.49: This staircase near Rainey Street lacks infrastructure for water access, resulting in trampling.
